ALLISON HYBRID

ESS UPDATES

Instructor Led Training

ALLISON HYBRID H 40/50 EP

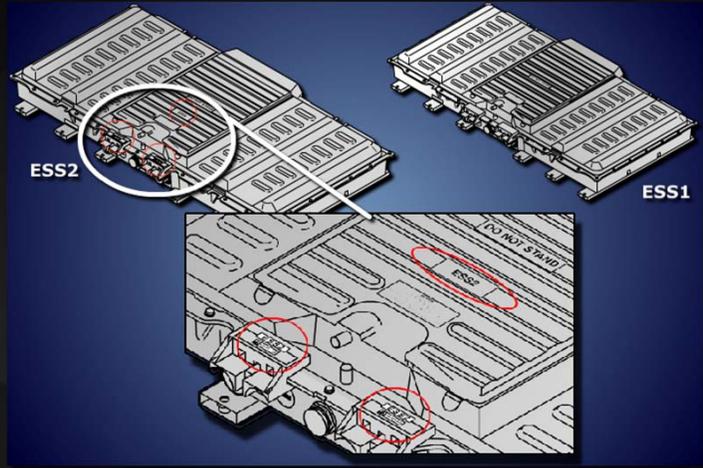
Release of ESS2

- Second generation Energy Storage System (ESS2) was released effective February 2010.
 - Differences between ESS1 and Ess2 are internal with the exception of identifying stickers on the lid and HVIL covers.
 - Both versions share the same connectors, pins, mounting points and external dimensions.
 - ESS2 should be used to service all ESS units (ESS1 and ESS2).
 - Reference SIL 22-EP-09 for details.

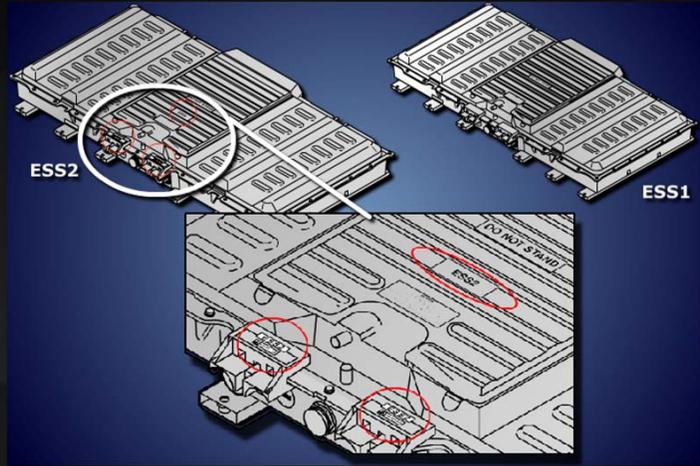
Release of ESS2 (Cont'd)

- The same components that are serviceable for the ESS1 are serviceable for the ESS2.
 - ESS2 Nickel Metal Hydride (NiMH) modules are wider which necessitated some internal harness, support and bracket changes to accommodate the additional space claim.
- Battery Controller Interface Modules (BCIMs) look identical but require different software.
 - Installing the wrong BCIM results in DTC 76-61 which shuts down the vehicle's high voltage system.

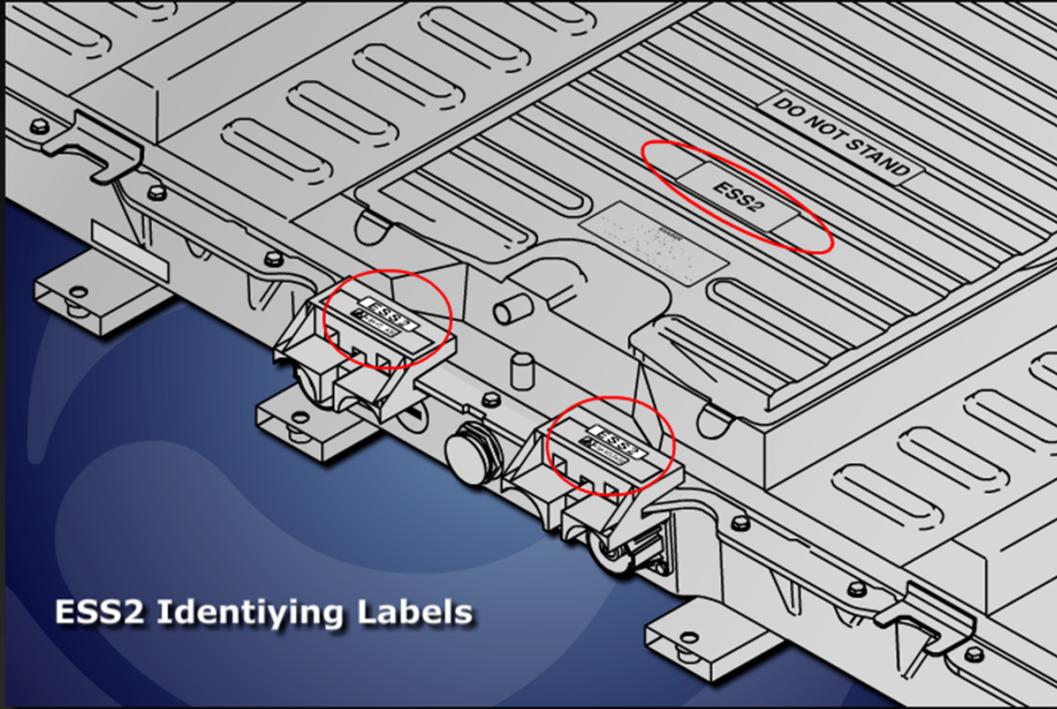
Identification

ESS2 Identifying Labels

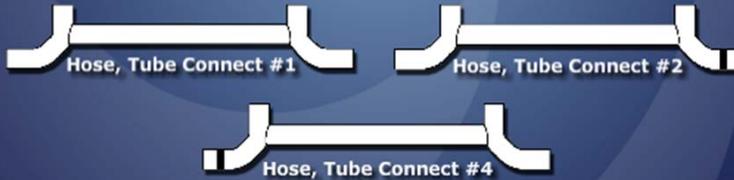
Former ESS1 Parts		Current ESS2 Parts	
Part Number	Description	Part Number	Description
P/N 29542840	Thermistor Assembly, No. 1	P/N 29550667	Thermistor Assembly, No. 1
P/N 29542841	Thermistor Assembly, No. 2	P/N 29550668	Thermistor Assembly, No. 2
P/N 29542842	Thermistor Assembly, No. 3	P/N 29550669	Thermistor Assembly, No. 3
P/N 29542843	Thermistor Assembly, No. 4	P/N 29550670	Thermistor Assembly, No. 4
P/N 29542844	Thermistor Assembly, No. 5	P/N 29550671	Thermistor Assembly, No. 5
P/N 29542845	Thermistor Assembly, No. 6	P/N 29550672	Thermistor Assembly, No. 6
P/N 29549707	Battery Controller Interface Module (BCIM)	P/N 29550673	Battery Controller Interface Module (BCIM)
P/N 29542871	Pillar, Support	P/N 29550676	Pillar, Support
P/N 29542885	Hose, Tube Connect No. 1	P/N 29550679	Hose, Tube Connect No. 1
P/N 29542886	Hose, Tube Connect No. 2	P/N 29550680	Hose, Tube Connect No. 2
N/A	N/A	P/N 29550681	Hose, Tube Connect No. 4

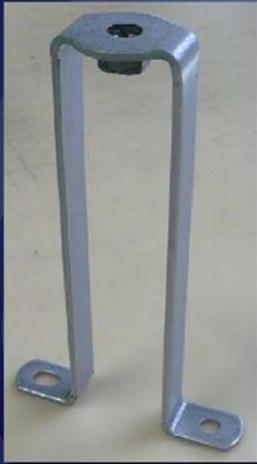
Former ESS1 Parts		Current ESS1/ESS2 Parts	
Part Number	Description	Part Number	Description
P/N 29542872	Pipe, Support Upr Cover	P/N 29550677	Support Upr, Cover
P/N 29543217	Brkt, S/P	P/N 29550678	Brkt, S/P

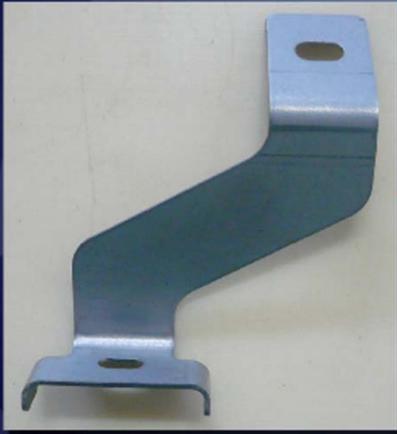
Former ESS1 Parts		Current ESS1/ESS2 Parts	
Part Number	Description	Part Number	Description
P/N 29542872	Pipe, Support Upr Cover	P/N 29550677	Support Upr, Cover
P/N 29543217	Brkt, S/P	P/N 29550678	Brkt, S/P

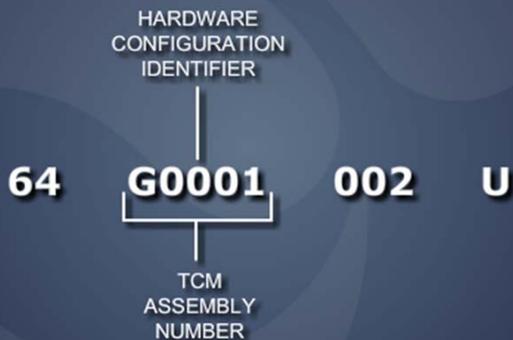
ESS2 Software Configuration Example

Identify the TCM Assembly Number in the SID

- Download the new SID as a TCM Assembly Number by adding an "HEV" prefix; for example:
 - An ESS1 is being replaced with an ESS2 in a bus with SID 64-G0001-002-U.
 - The TCM Assembly Number is represented by SID fields 3 through 7 (G0001), so the installing technician should onto the PCCS web server and download HEVG3001 using the TCM Assembly Number download option (the "3" in this number is the hardware configuration identifier indicating MY07 engine; Pre-4th Generation TCM/VCM; DPIM1; ESS2).

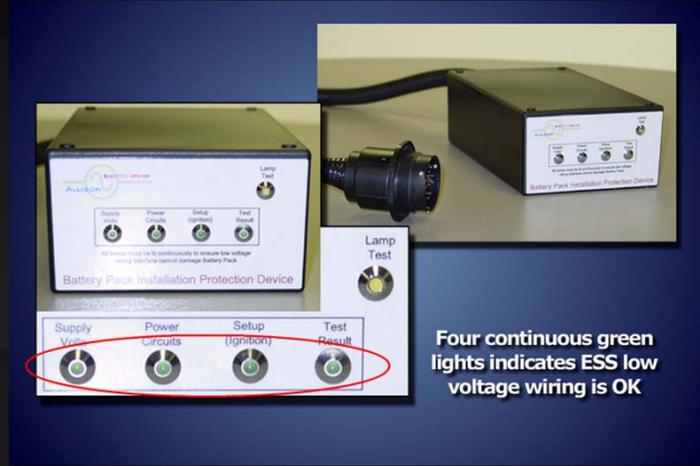
Battery Pack Installation Protection Device (BIPD) Test Procedures Update

- The maximum/minimum allowable voltage to prevent possible damage to ESS reference table has been updated by the tool manufacturer.
 - Reference SIL 3-EP-10 for details.
 - This updated information is included in the latest version of Allison Technical Publications (Troubleshooting and Service Manuals).

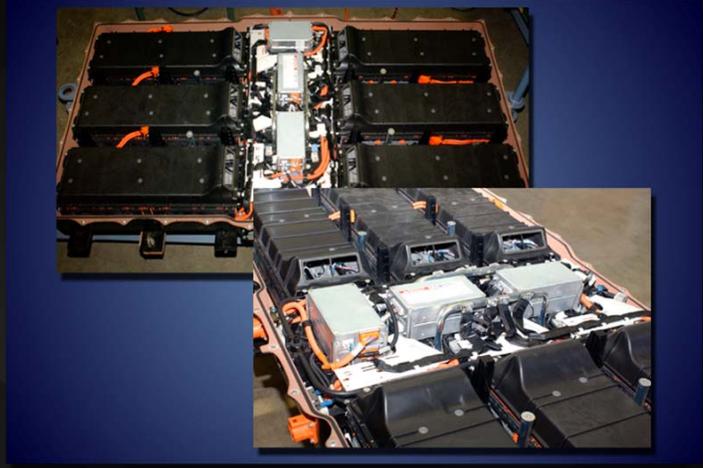
ESS1 Refresh Kit

- An ESS1 battery update and refresh kit is available effective February 2011.
 - *This refresh kit updates ESS1 units with ESS2 battery sub-packs.*
 - *An additional conversion kit is available when installing the refresh kit for the first time.*

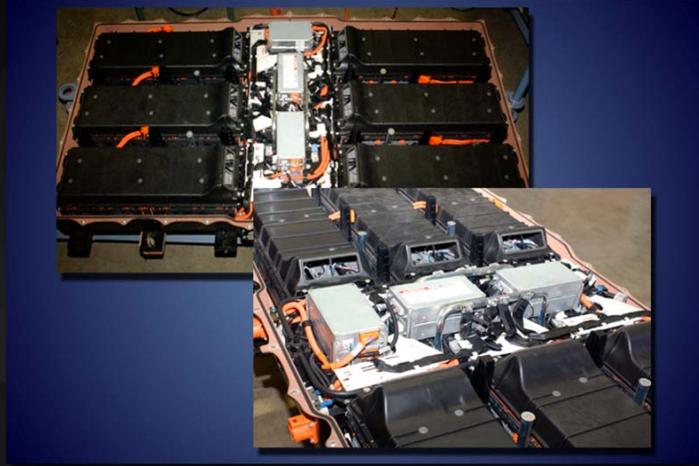
ESS1 Refresh Kit (Cont'd)

- Kit installation details are included in SIL 10-EP-10.
 - *Reference the ESS Service Manual (SM4162) for general ESS disassembly and reassembly procedures.*
 - *Updated data tag and stickers are included to indicate the ESS has been updated.*
- **A new SID must be reflashed to the entire vehicle when an ESS Refresh Kit is installed.**
 - *Reference the software update procedures covered in this module and in SIL 10-EP-10.*
