ALLISON HYBRID

DIAGNOSTICS — TROUBLESHOOTING SCENARIOS

ALLISON HYBRID H 40/50 EP Diagnostics — Troubleshooting Scenarios

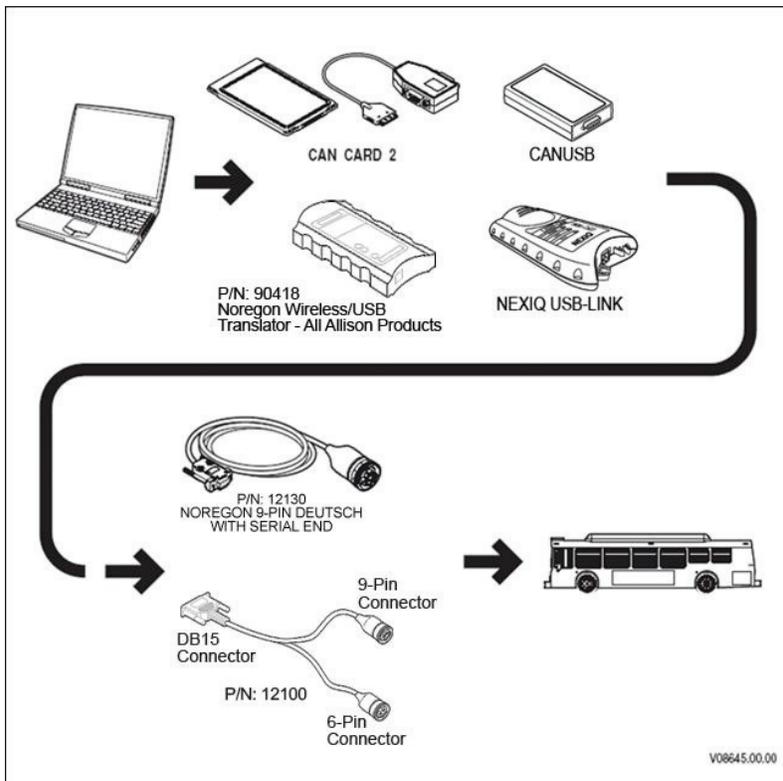
RESOURCES: Connection Diagram

Use the Noregon harness part number 12130 (or 12100) to connect the Softing (or usbLink, DLA+Wireless) translator device to the vehicle connector. The diagram below illustrates the hardware connections between the PC hosting Allison DOC ® For PC (H 40/50 EP), the Softing translator device or usbLink or DLA+Wireless, and the 12130 or 12100 harness.

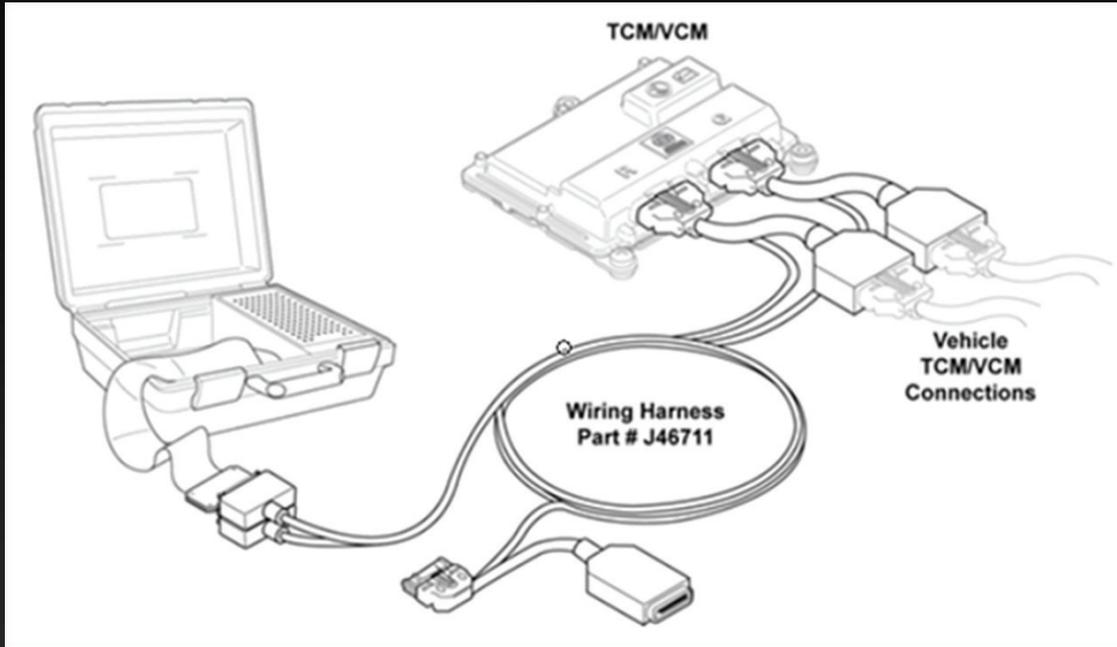
Breakout Box to TCM Connection

Breakout Box To TCM Connection

- Continuity, voltage and resistance checks are often part of troubleshooting procedures.
 - *These are sometimes called “pin out” checks.*
- The breakout box eases pin out check procedures and minimizes the chance of damage to vehicle connectors.
 - *The breakout box installs inline with system components.*
 - *Multiple “overlays” and harnesses are available so the breakout box can be used with the TCM/VCM, DPIM, Drive Unit and ESS.*

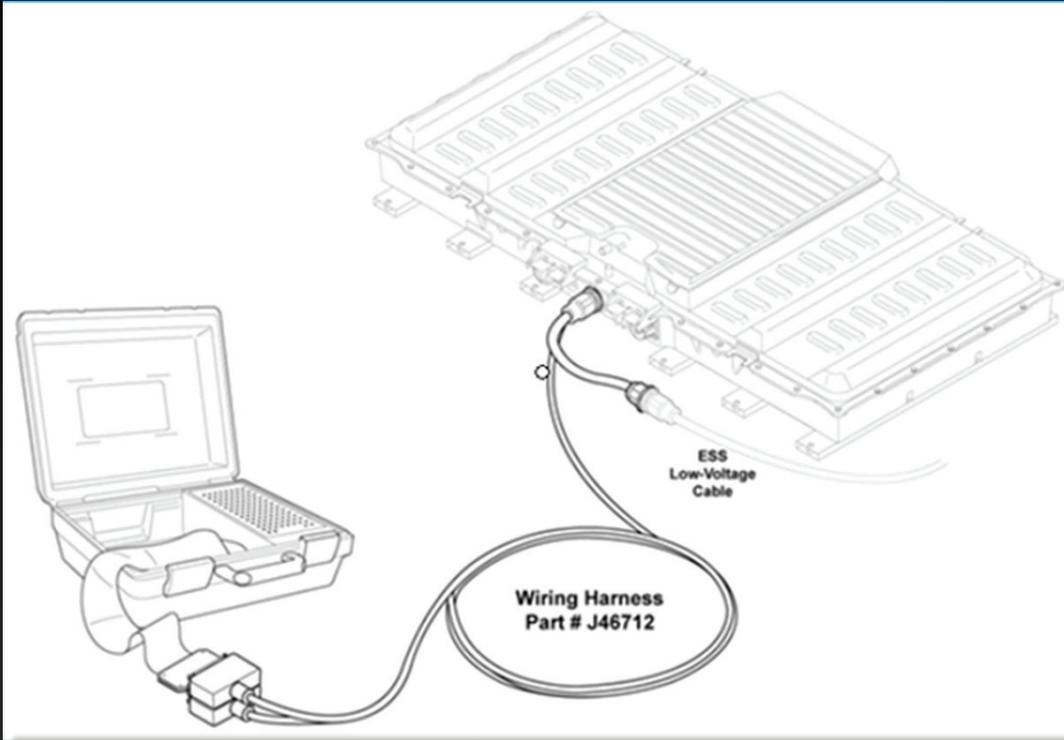
Breakout Box to ESS Connection

Breakout Box To ESS Connection

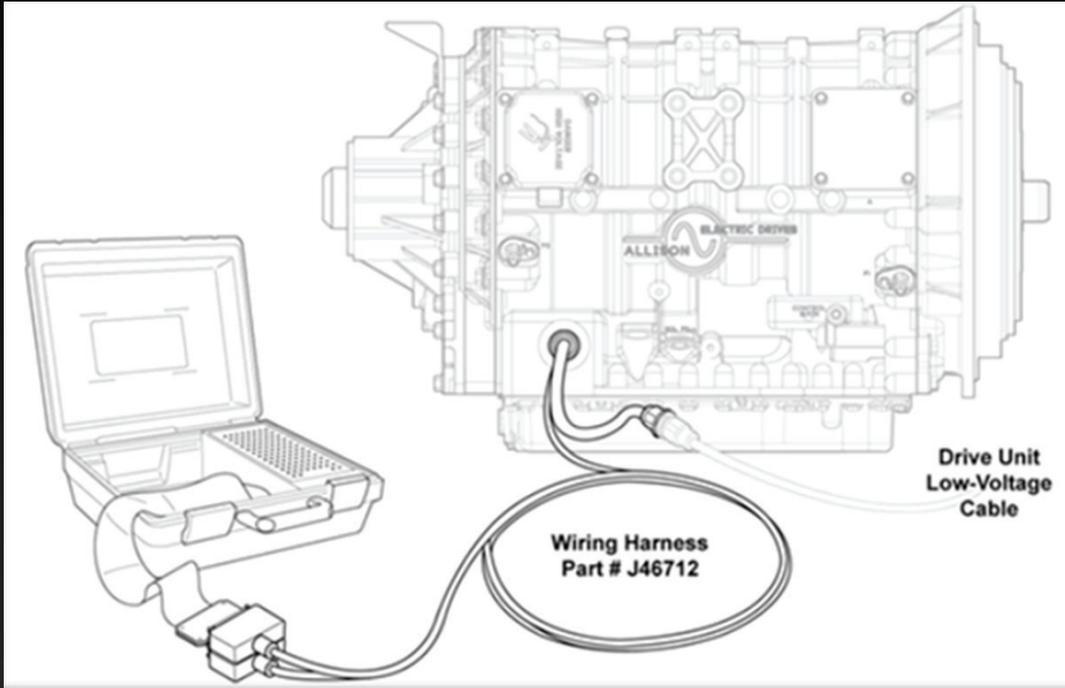
Breakout Box to Drive Unit Connection

Breakout Box To Drive Unit Connection

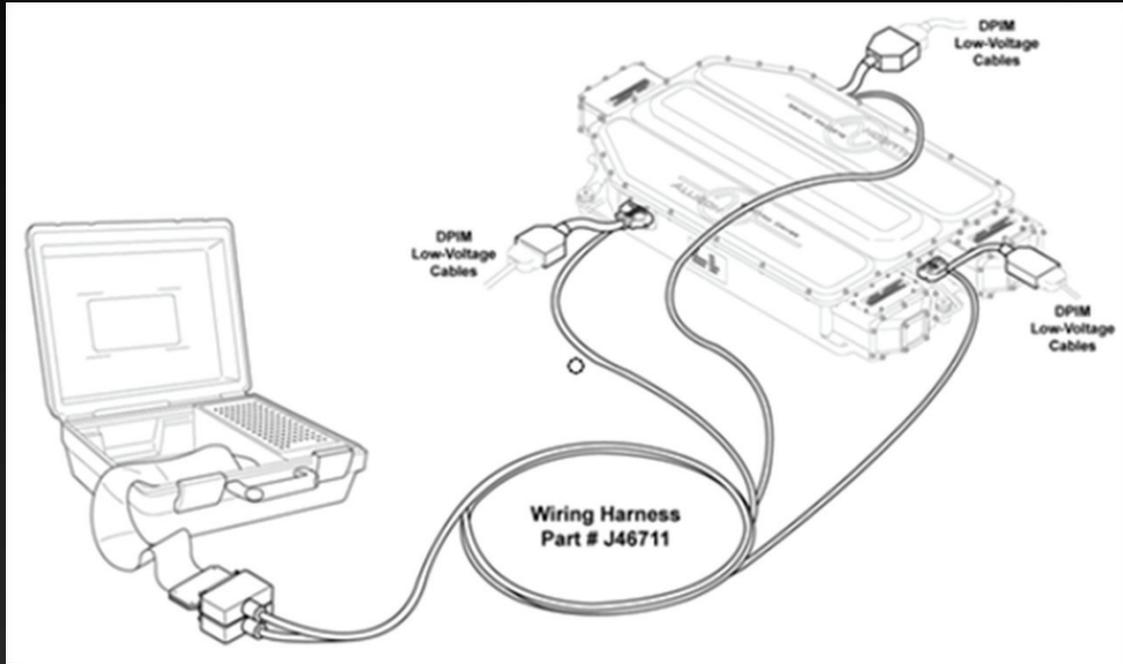
Breakout Box to DPIM Connection

Breakout Box To DPIM Connection

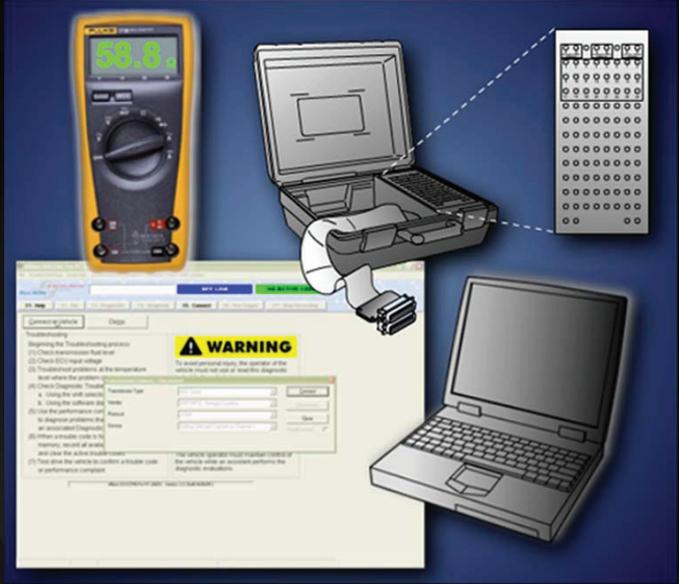
Scenario #1

- Diagnostic Codes:
 - 17-21, 44-15, 66-21, 66-33.
- Codes with a 66 prefix are communications codes and should be diagnosed first.
- Use Allison DOC™ to:
 - Verify TCM is commanding signal over wire 323 in the Data Monitor.
 - Verify with the ESS Data Monitor that the ESS is awake and functioning.
- Perform pin out checks at the TCM and ESS with the breakout box.
- Troubleshoot harness wires for continuity problems.

Code 66-21 in the TS Manual indicates starting with code 44-15 if present
Code 44-15 indicates a problem with the ESS Wakeup Signal
Wiring schematic shows TCM wire 323 carrying ESS Wakeup Signal

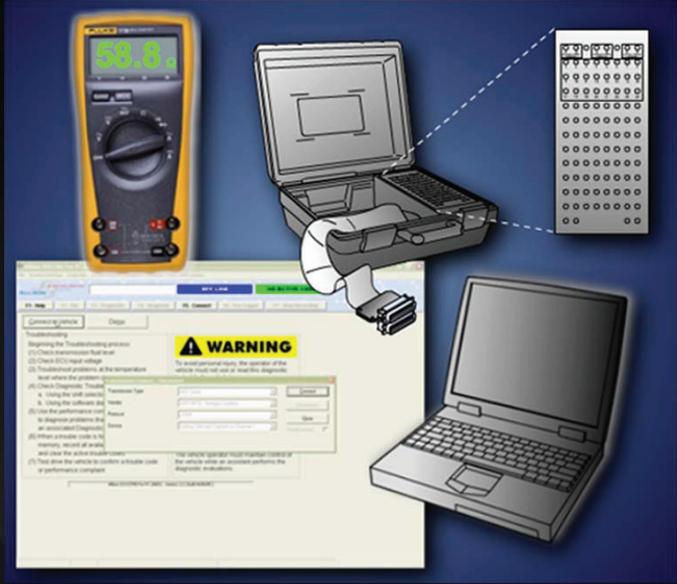
Scenario #2

- Diagnostic Codes:
 - 25-20, 44-19, 66-18, 66-19, 66-31, 66-32, 80-32.
- Codes with a 66 prefix are communications codes and should be diagnosed first.
- Use Allison DOC™ to:
 - Verify a missing wakeup signal.
- Perform pin out checks at the TCM and DPIM with the breakout box.
- Troubleshoot harness wires and relays for continuity problems.

Code 66-18 in the TS Manual indicates starting with code 44-19 if present
Code 44-19 indicates a problem with TCM side of inverter wake-up relay
Wiring schematic shows TCM wire 428 carrying DPIM Wakeup Signal

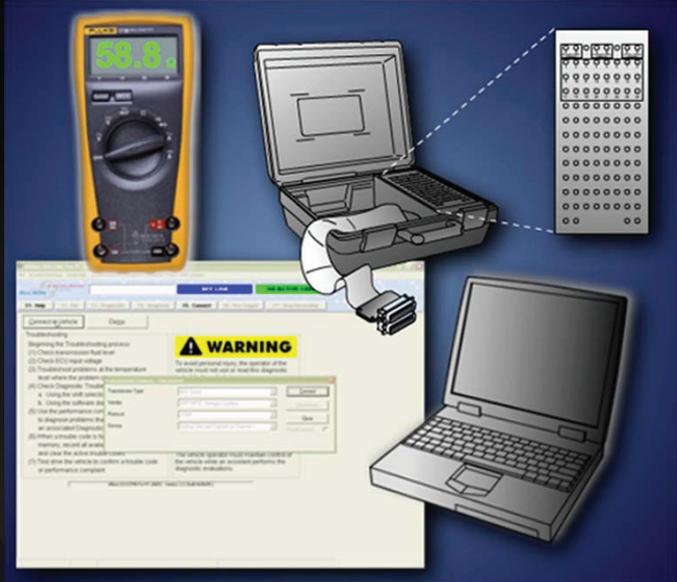
Scenario #3

- Diagnostic Code:
 - 73-32.
- Use Allison DOC™ Data Monitor to view Motor A and B Temperature.
- Use the breakout box to perform pin out checks at the DPIM and Drive Unit.
- Use continuity checks to troubleshoot harness wires and relays.

The TS Manual recommends checking temperature values for Motors A & B

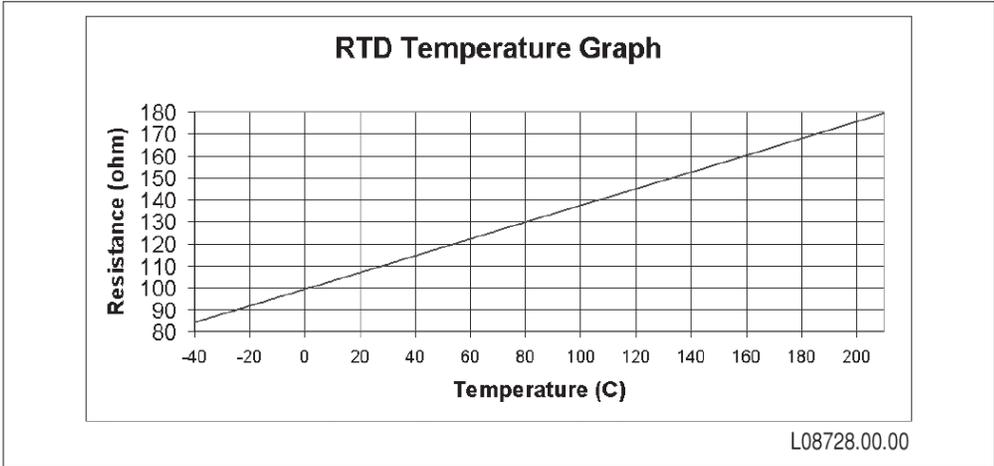
Resistance vs. Temperature

DTC 73-32 Inverter A Motor Temperature Out-of-Range High
